HOMESPEC REAL ESTATE INSPECTIONS

February 20, 2023

Reference: 1012 North Drive, Copperas Cove, TX 76522

At your request, an inspection of the property located at the above referenced address was conducted this morning. The following observations were made during the course of the inspection:

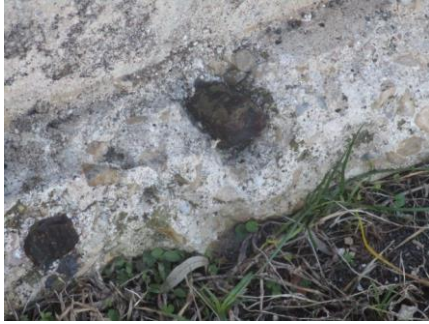
1. Exposed rebar at several areas around the house.

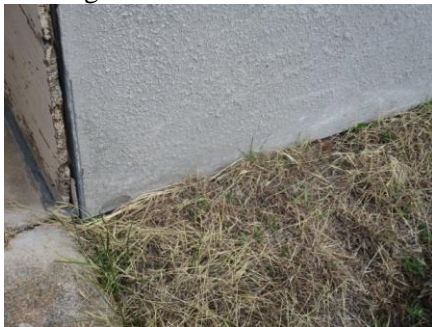
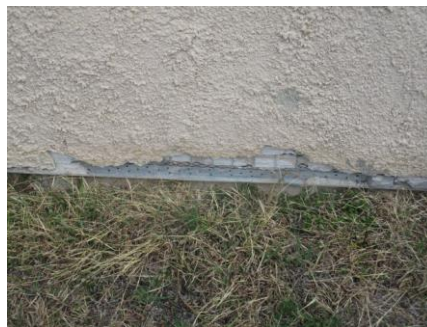
2. Inadequate clearances between the siding and the soil at several areas around the building.

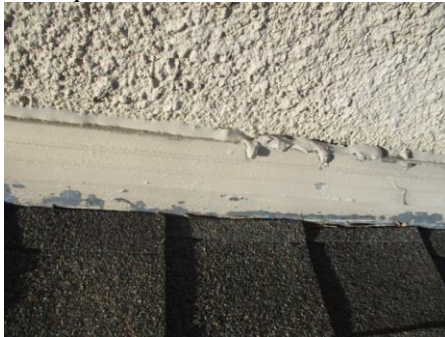
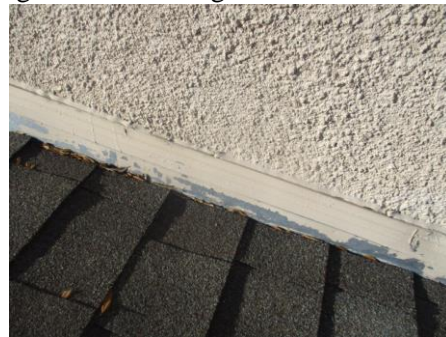
3. Inadequate clearances between the siding and the flashings at the roof to wall transitions.

The exterior stucco cladding is damaged in a number of areas around the building and improperly installed. The flashings at the roof to wall transitions terminate behind the cladding; thus directing water into the wall cavity and inadequate clearances between the flashings at the roof to wall transitions which does not allow water to weep out from behind the stucco at the weep screed. The cladding is also installed too close to the soil around the building. There should be at least six inches between the cladding and the soil to prevent moisture from wicking up through the stucco and also to reduce the likelihood of wood destroying insects from entering the wall.

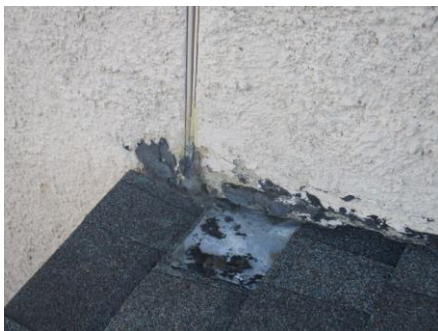
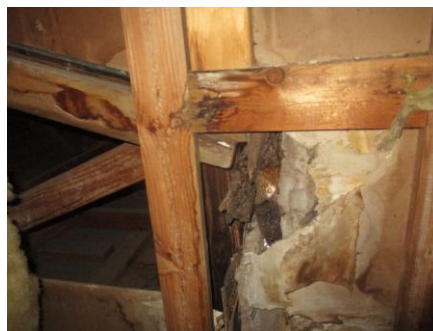
4. Improper termination of the flashings behind the stucco cladding at the roof to wall transitions.

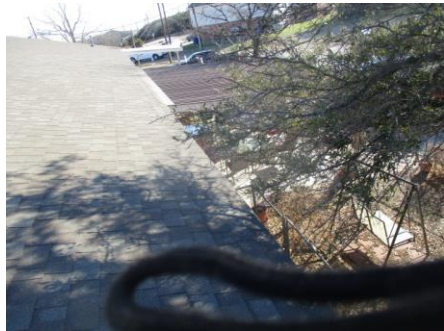
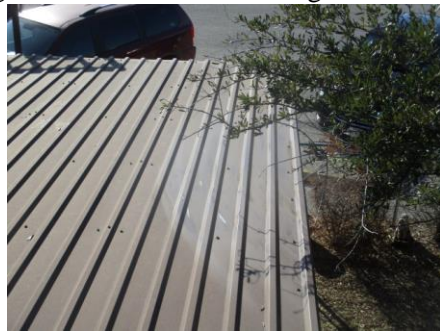
5. Tree limbs too close to the roof covings at the rear of the building.

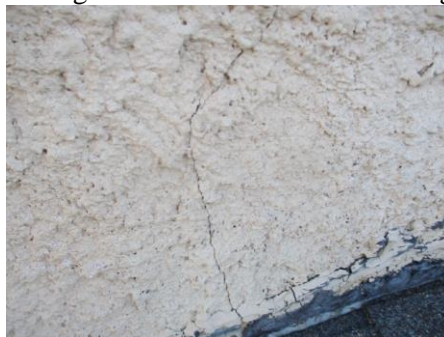
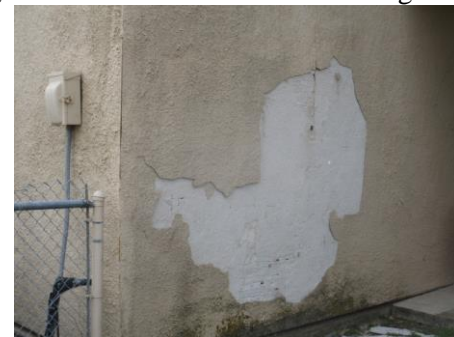
6. Damaged and cracked stucco cladding around the exterior of the building.

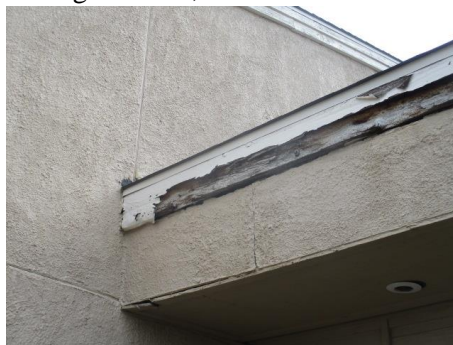
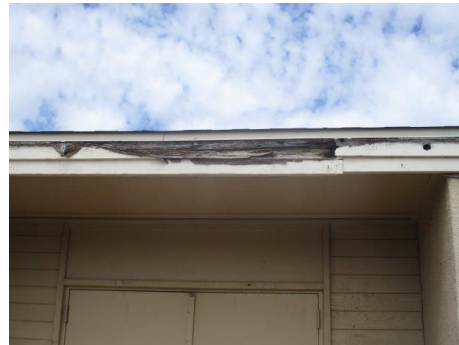
7. Damaged fascia, soffit and trim.

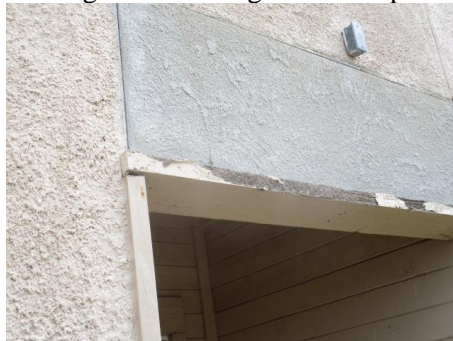
8. Missing head flashing above the protruding exterior trim.

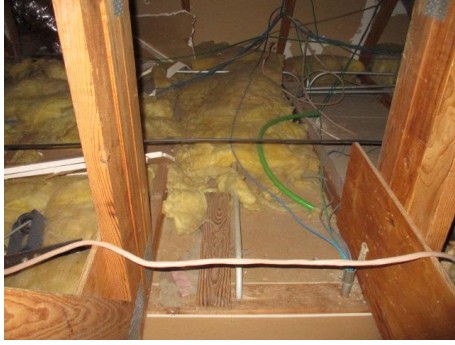
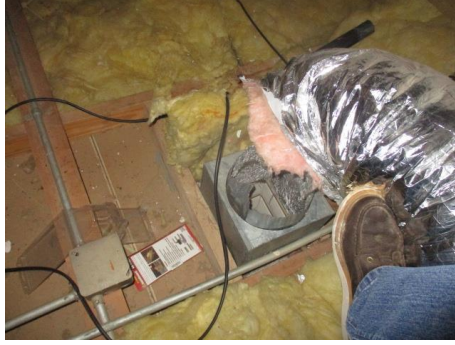
9. Missing and improperly installed batt insulation throughout the attic.

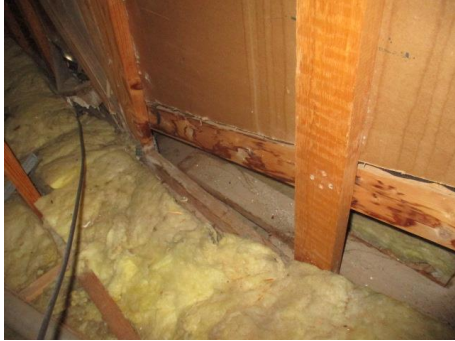
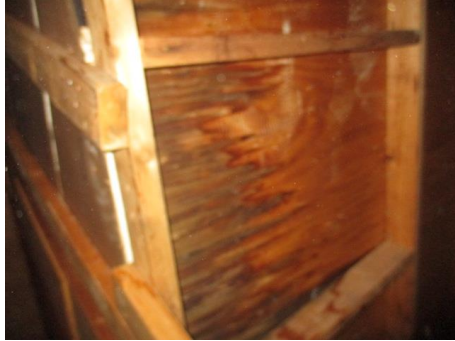
10. Stains on the trusses, sheathing on the gable ends and roof decking.

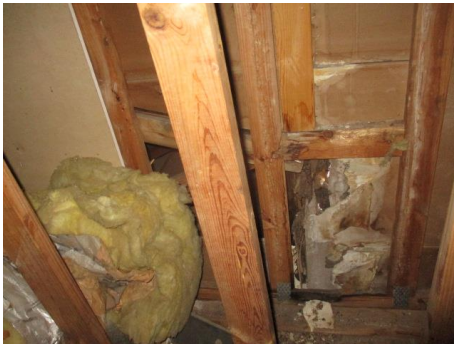
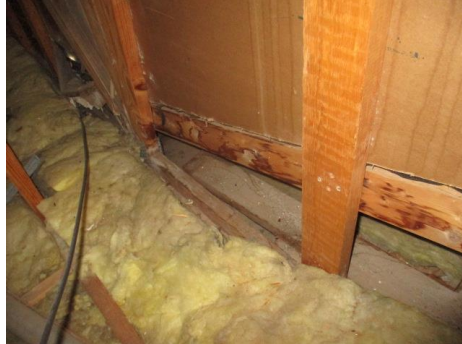
11. Damaged sheathing on the gable ends from the improper termination of the flashing behind the cladding at the roof to wall transitions.

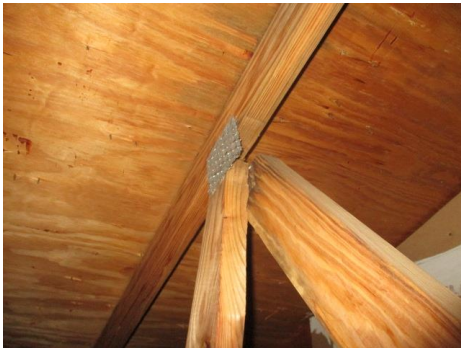
12. Loose web members on trusses.

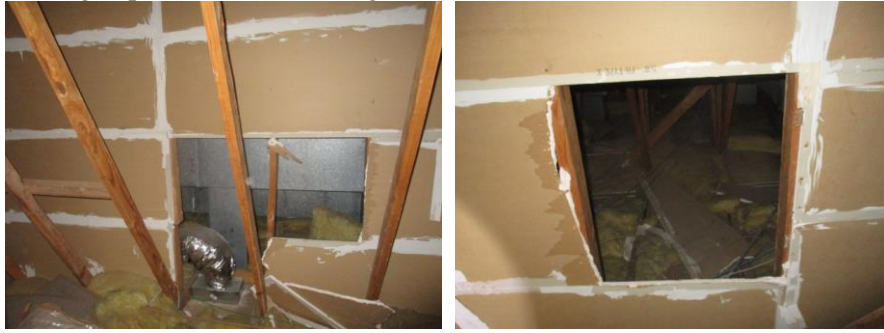
15. Damaged partition walls throughout the attic.

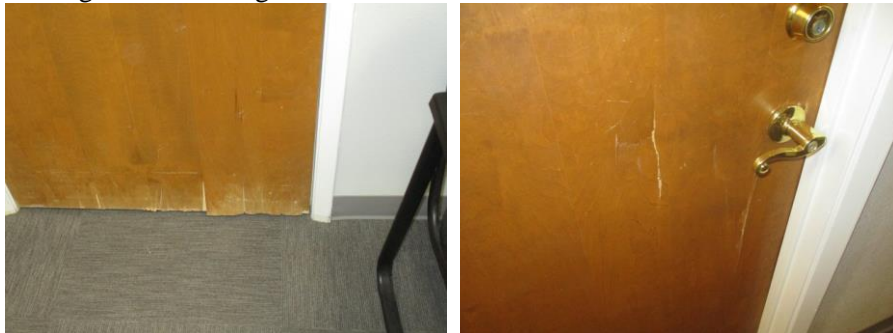
16. Damaged and missing interior doors.

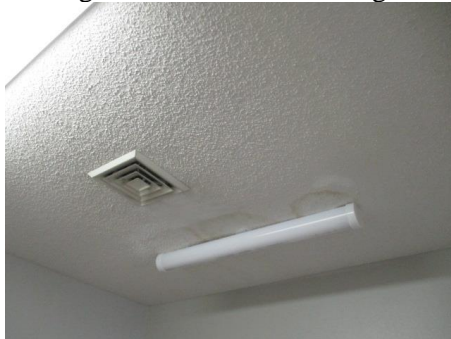
17. Damaged finishes on the ceilings in several areas of the building.

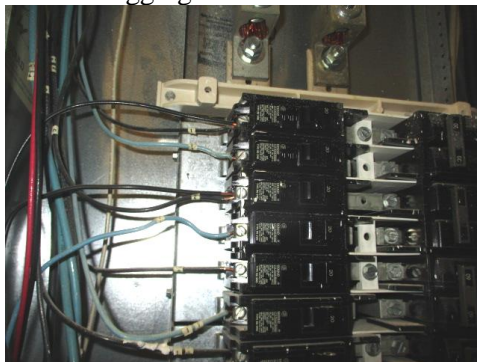
19. Double lugging on breakers.

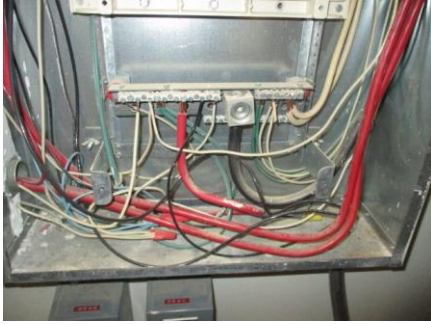
20. Double lugging on the neutral buss bars in the panels.

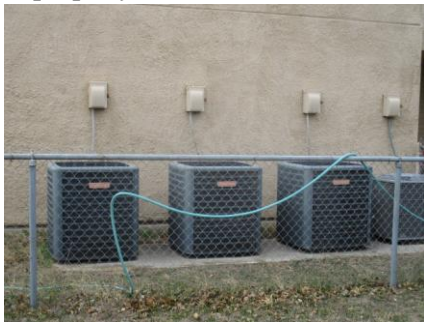
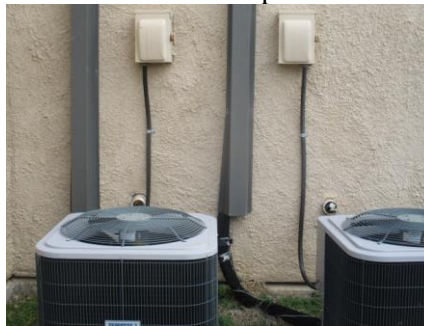
22. Improperly located AC service disconnects behind the compressors.

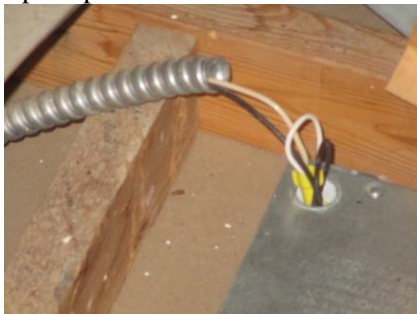
23. Open splices in the attic.

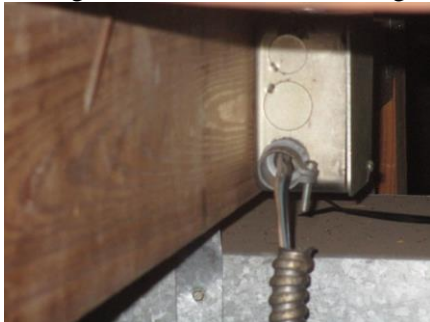
24. Damaged electrical conduit throughout the attic.

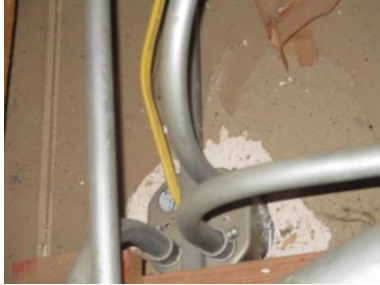
25. Romex branch wire installed in the attic.

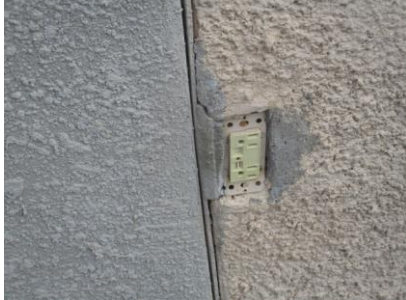
26. Missing weather proof cover plates at the exterior of the building.

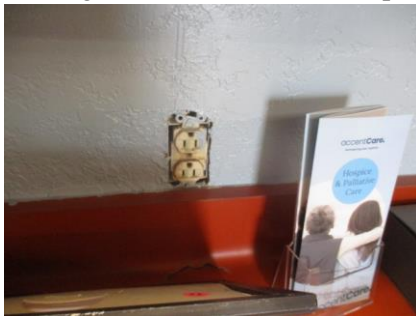
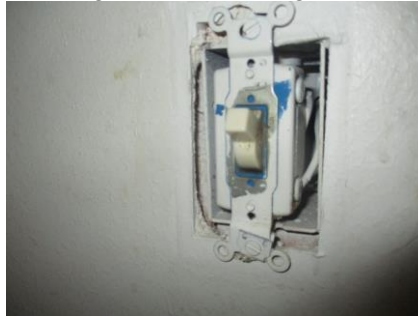
27. Missing switch and outlet cover plates throughout the building.

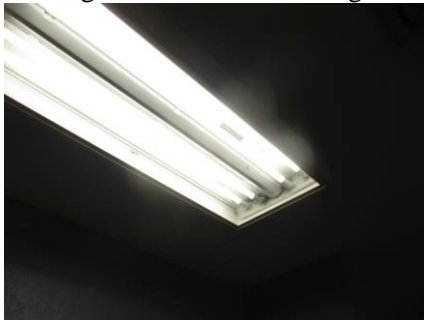
30. Missing lens on fluorescent light fixtures.

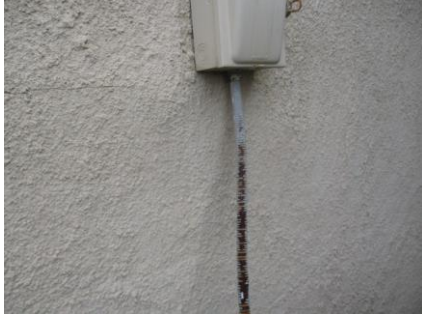
31. No strap on the flex conduits at the AC compressor service disconnects.

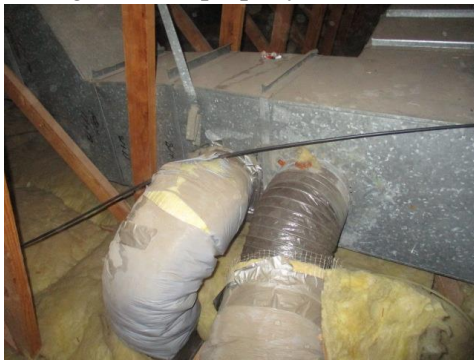
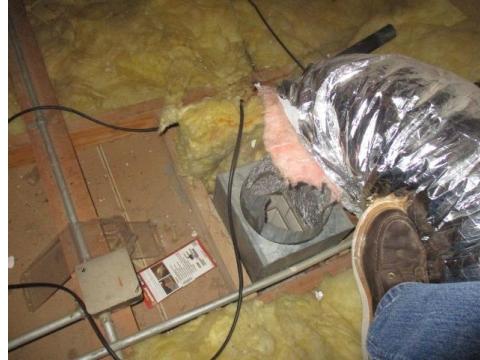
33. Damaged and improperly installed flex ducts throughout the attic.

Again, there were several HVAC systems that we were unable to operate due to the locks on the thermostats and there was one system in the middle of the building that would not operate. The HVAC duct system in the attic is damaged throughout. Both the systems and the ducts should be evaluated by a mechanical contractor.

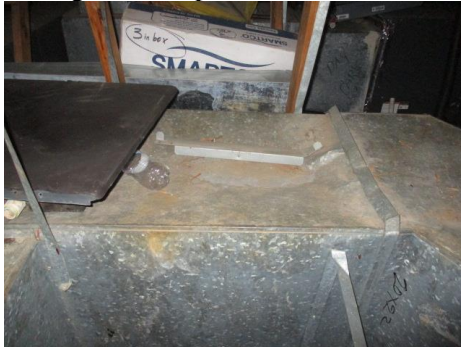
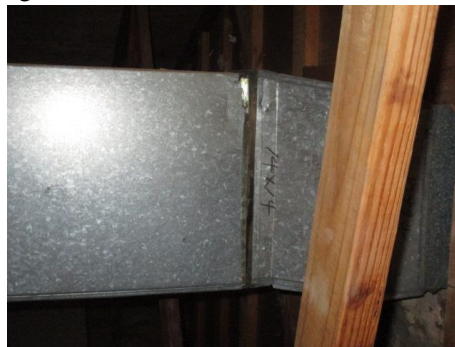
34. Damaged and separated metal ducts throughout the attic.

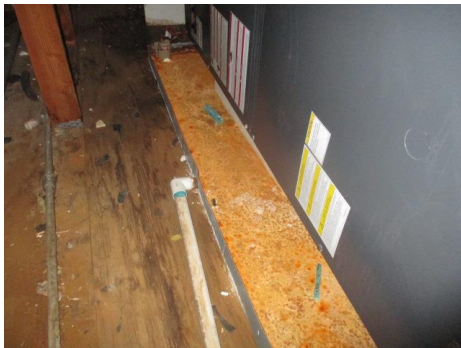
35. Rust and debris in some of the HVAC secondary condensate pans.

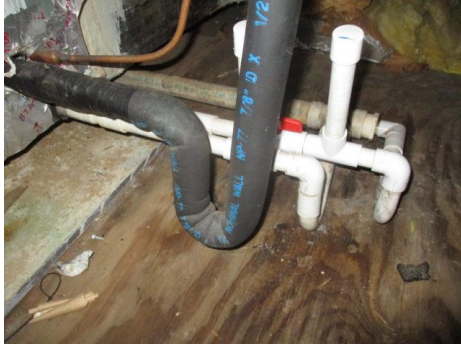
36. Missing insulation on the primary condensate drain lines throughout the attic.

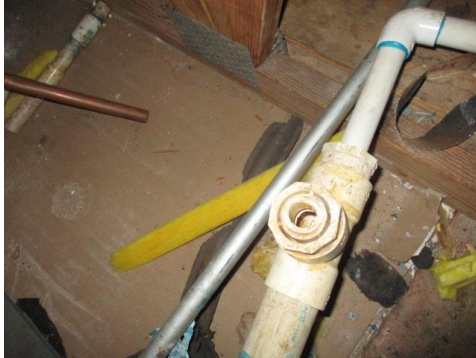
37. Open sewer vent lines.

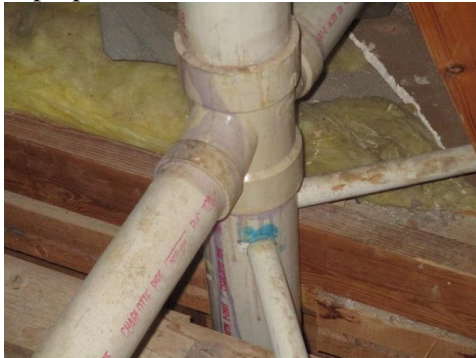
38. Improper termination of the condensate drain lines into un-trapped sewer lines.

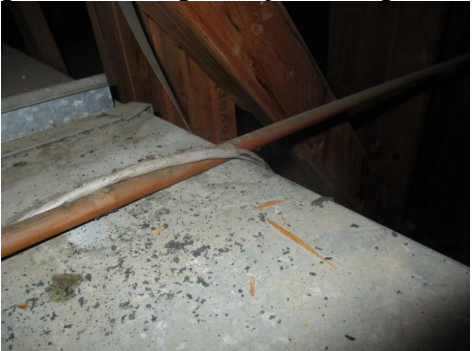
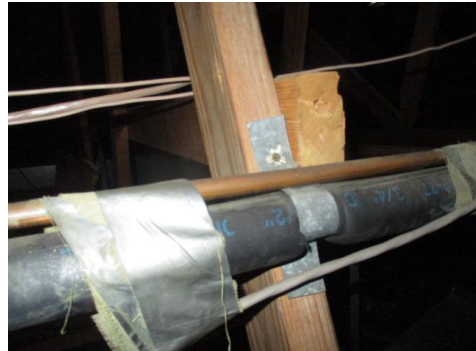
39. Dielectric connections between the copper return lines on the HVAC system and the galvanized hanger strap and the galvanized metal ducts.

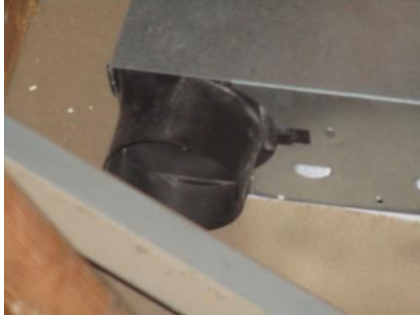
40. Limited inspection of the four of the HVAC systems due to locked boxes on the thermostats.
41. One of the HVAC systems in the center of the building was not working.
42. The bathroom exhaust vents improperly terminate into the attic area.

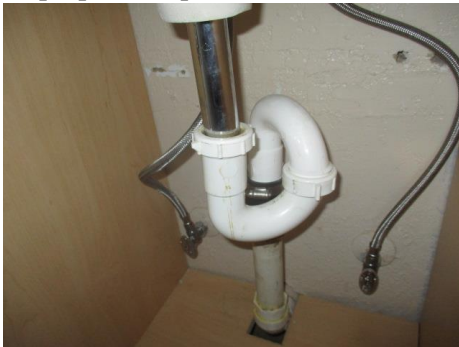
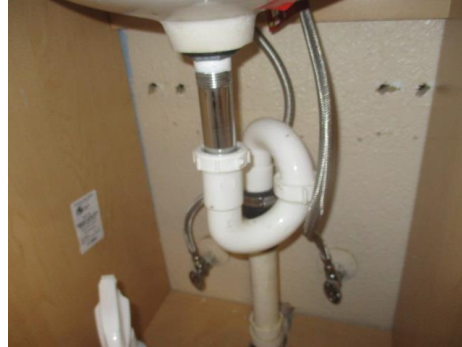
44. Improper S-traps installed under some of the bathroom lavatories.

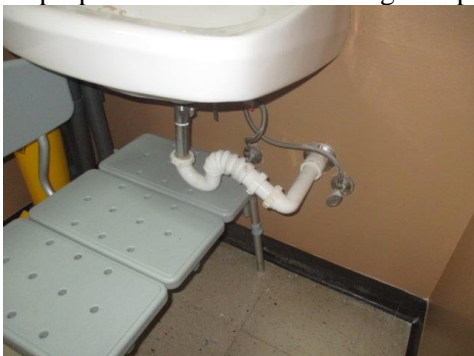
45. Improper drain lines and missing P traps installed under some of the bathroom lavatories.

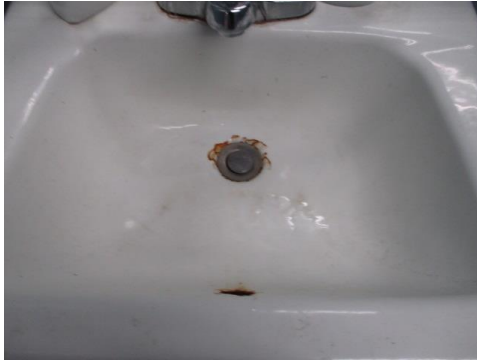
46. The kitchen sink in the kitchen on the left end of the building is loose from the kitchen countertop.
47. Rust on one of the bathroom lavatories on the left end of the building.
